# Eagles Eye Home Inspection

## HOME INSPECTION REPORT

**Overview:** Standard home inspection of a single family dwelling.

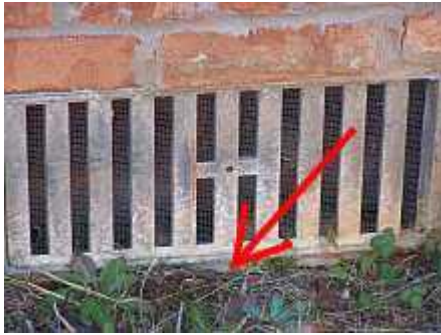
**Photo 5**

**2)** One or more crawlspace vents are below or too low to grade with no well to prevent rainwater from entering. This can lead to water entering and accumulating in the crawl space, and is a conducive condition for wood destroying insects and organisms. Recommend raising vent above grade or

This vent is installed too low to the ground. Water can enter into crawl space if this area floods. Recommend raising crawl space vent higher if possible.

installing or constructing wells at below-grade crawlspace vents.

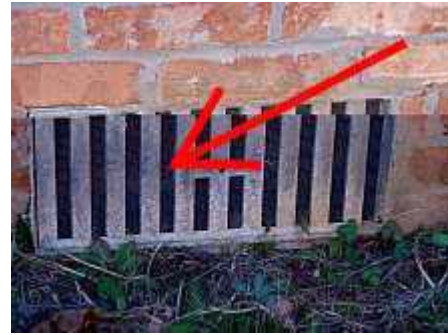
**Photo 6**

Vent installed too low to ground. Water can enter into crawl space.

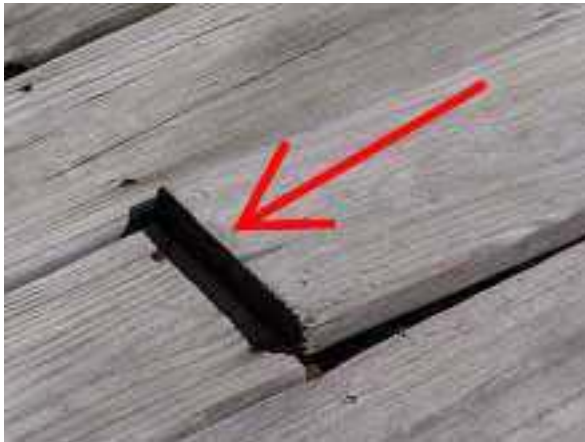
**Photo 11**

**3)** The finish on the deck is worn and/or deteriorated. Recommend cleaning and staining deck also replace damage boards and nail down lifting decking boards.

Decking boards lifting and deck need treating with weather protection.

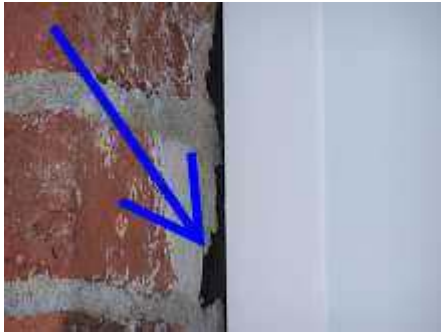
**Photo 7**

**4)** Caulk is missing or deteriorated in some areas. Recommend caulking where necessary. Need clear caulk around all windows and around garage door.

Caulk gaps around garage door with clear caulk.

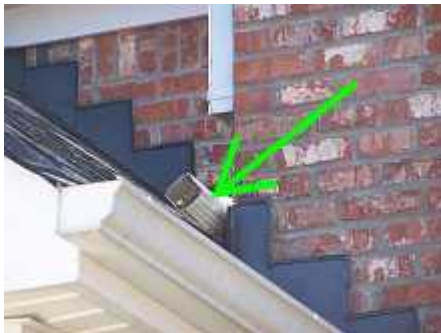
**Photo 3**

Gutter elbow not attached.

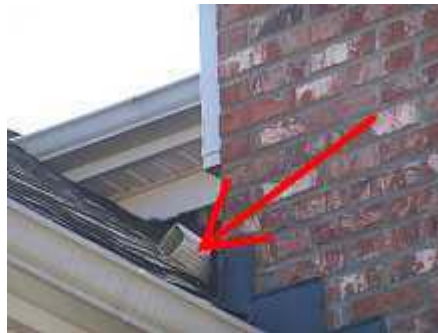
**Photo 4**

**6)** Gutter elbow not attached.

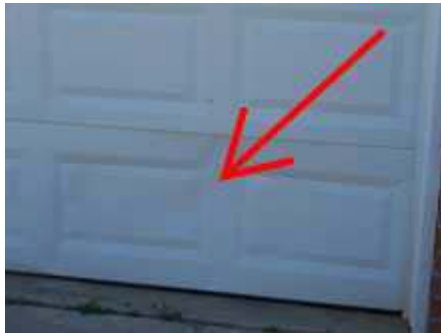
**Photo 8**

7) One or more garage vehicle doors are damaged. Recommend having a qualified contractor make repairs as necessary.

Garage door bent at this section.

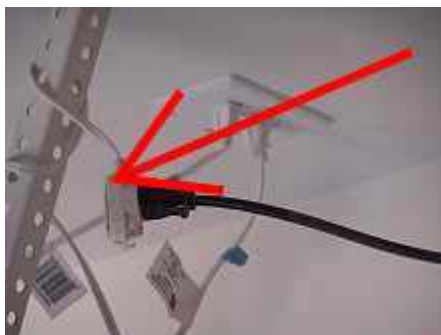
**Photo 43**

8) Recommend installing electrical receptacle closer to garage door openers. This will allow enough room to plug-in electrical cord without using a extension cord.

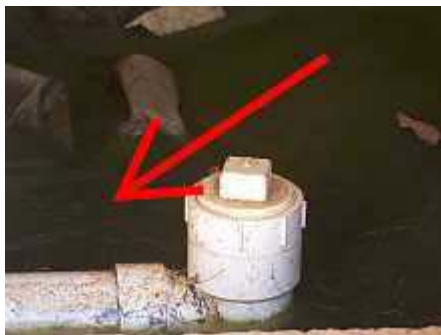
**Photo 14**

**17)** The crawl space is flooded with water. Recommend pumping water out to evaluate damages and remove all plastic barrier so that crawl space can dry out. After crawl space has dried out, recommend that a heating and air specialist evaluate A/C unit in crawl space for damage. Recommend having a structural engineer examine foundation. Insulation should be removed/replaced. Recommend having a mold test done in crawl space.

Standing water in crawl space.  
Water is 3" to 4" Deep.

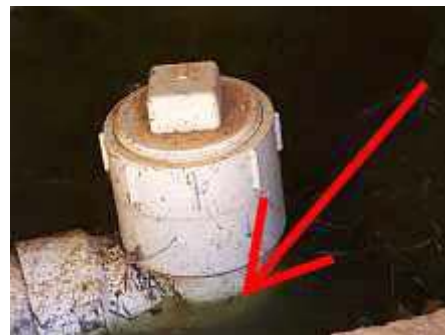
**Photo 15**

Crawl space flooded.

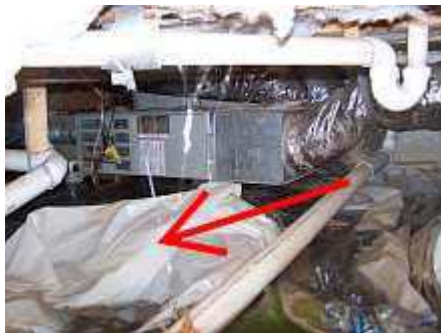
**Photo 17**

Plastic not installed correctly. Should lay flat with no gaps.

**18)** Vapor barrier needs repair. Recommend repairing vapor barrier so no exposed soil exists in the crawlspace. Recommend using 6 mil polyethylene with seams overlapped at least 24".

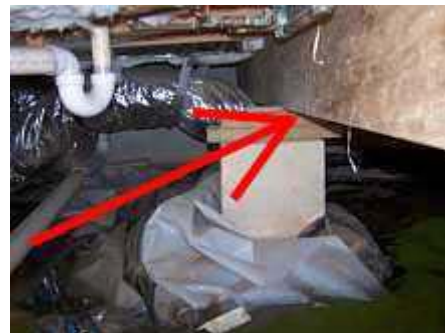
**Photo 18**

Wood blocks helping to hold-up sub floor.

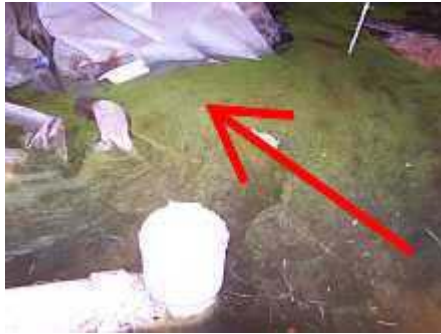
**Photo 19**

Recommend inspecting home for mold. Mold will form within 24 to 48 hour. The water need to be removed ASAP and remove 6 mil. plastic on ground under house and have the problem evaluated to determine what caused the flooding. This might have been an ungoing problem. It might be a spring--on the property that only occurs when the water table rises--- It might have clogged gutter..bad grading around the house/foundation--a underground water leak--neighbor might have his/her gutter run off going toward the house.. a broken plumbing line. Find the source ASAP to fix the problem.

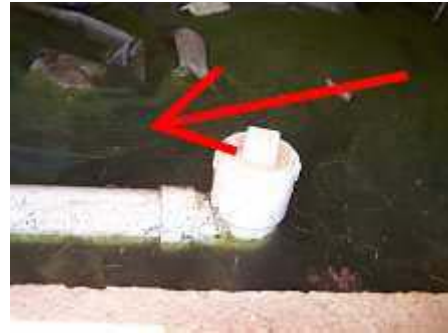
**Photo 20**

3" to 4" of water at this area.

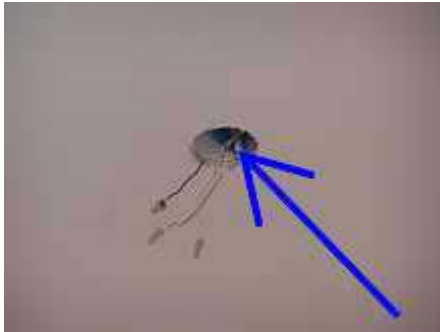
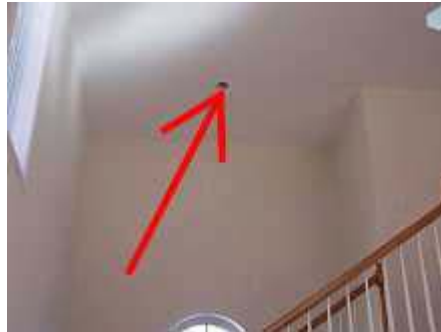
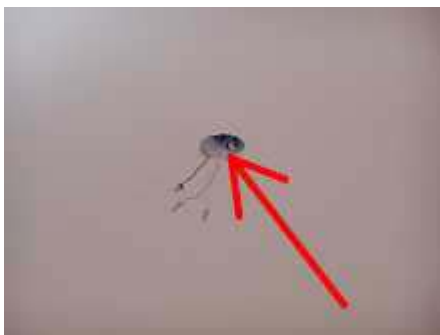
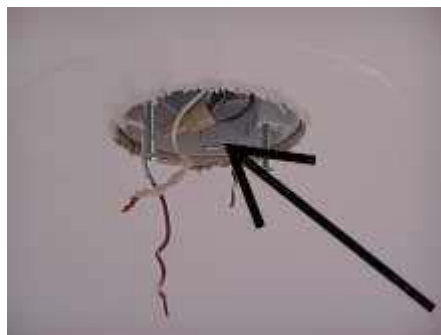
**20)** One or more light fixtures are missing. Recommend having a qualified electrician evaluate and repair or replace fixture(s) as necessary.

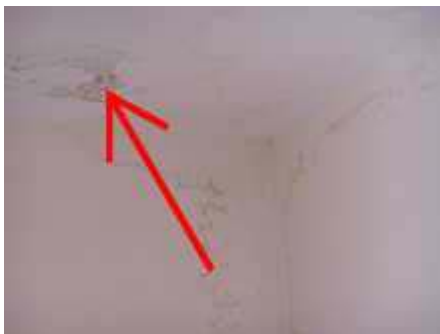
**Photo 28**

**21)** Water stains visible in ceiling, apparently or possibly from an active/previous leak from a plumbing pipe or jetted tub/shower. Recommend asking seller if leak was repaired. Recommend removing wet wallboard or plaster and replacing with new after area has dried thoroughly. Recommend doing a mold test on home.

Recommend doing a swab mold test and air sample test inside home. See other pictures.

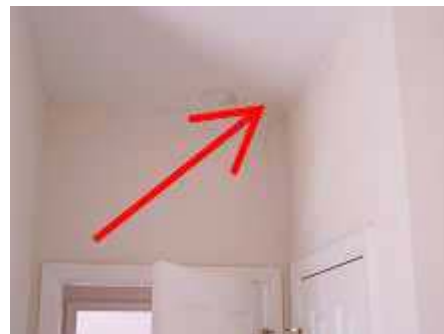
**Photo 29**

Water stains

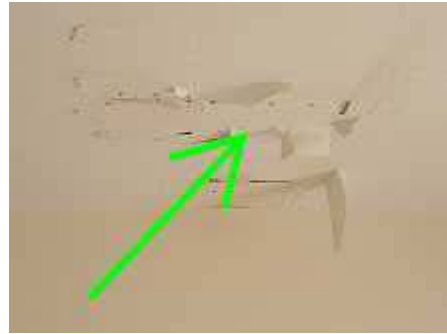
**Photo 31**  
Damaged ceiling.

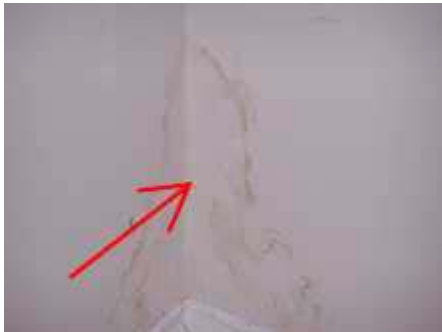
**Photo 35**  
Water stain

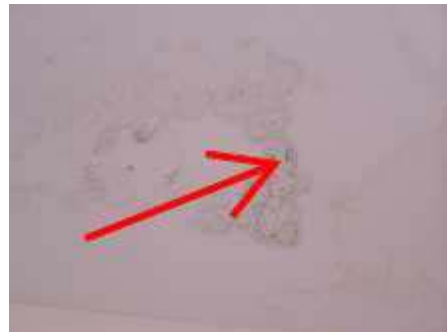
**Photo 41**

Ceiling patched. Might be due to a previous/active plumbing leak.

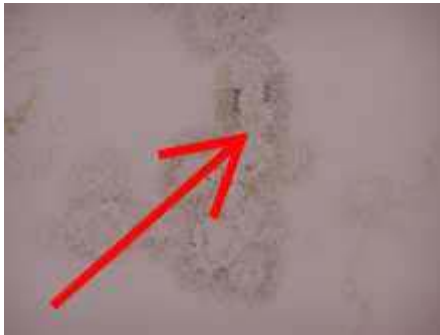
**Photo 42**

Recommend doing a mold swab test on this spot.

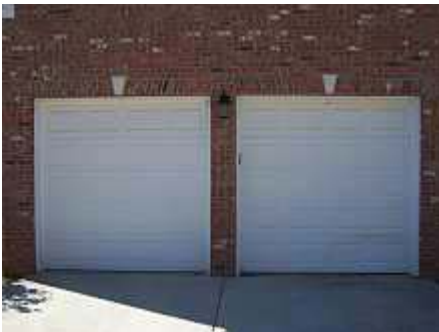
**Photo 9**

Caulk gaps around both garage door with clear silicone caulk.

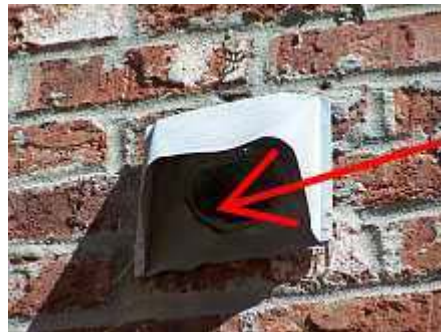
**Photo 10**

No vent cover installed.

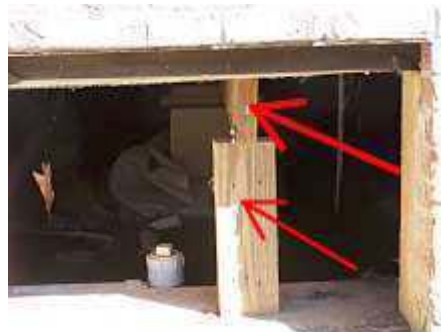
**Photo 22**

Wood bracing sub floor.

Joist could have been installed better and joist braced incorrectly with a wood block at entrance door. No crawl space door installed.

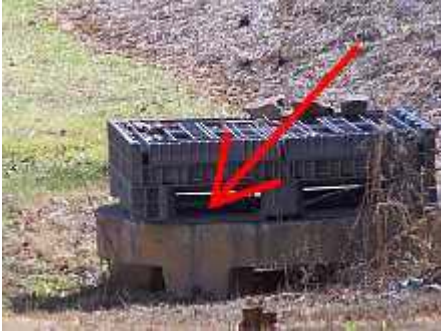
**Photo 23**  
Storm drain

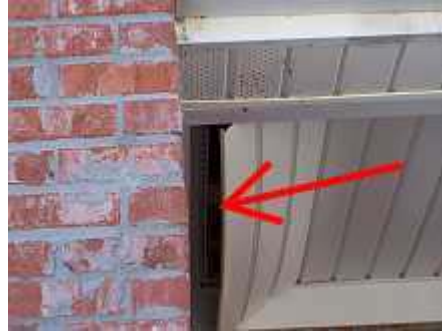
**Photo 24**  
Siding coming loose on front porch.

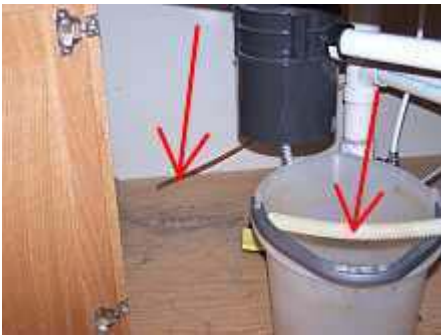
**Photo 32**  
Dishwasher line not attached

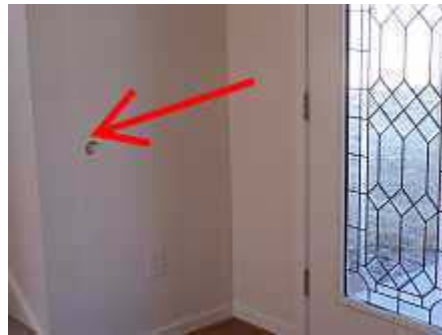
**Photo 38**  
Hole in wall from front door. No door stopper installed.

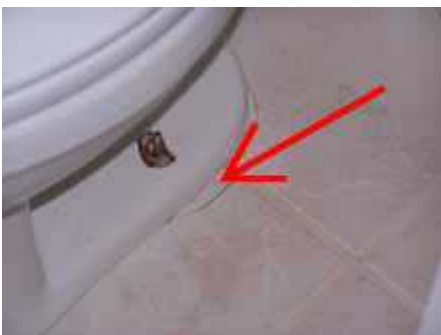
**Photo 40**  
Tile cracked around toilet near floor.
